# ASSESSMENT OF RC BUILDING STRUCTURES UNDER CONSTRUCTION SUBJECTED TO THE SUDDEN FAILURE OF SHORING ELEMENTS

**STRUCTURAL FAULTS & REPAIR**  
Edinburgh – May, 15th 2018

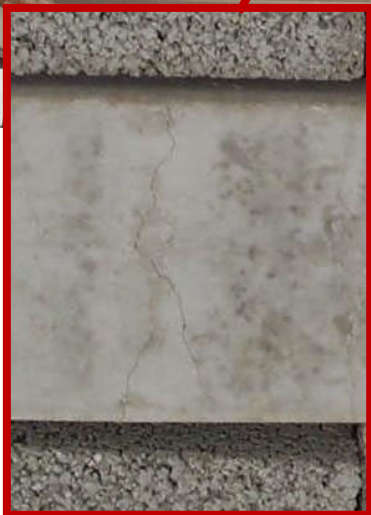
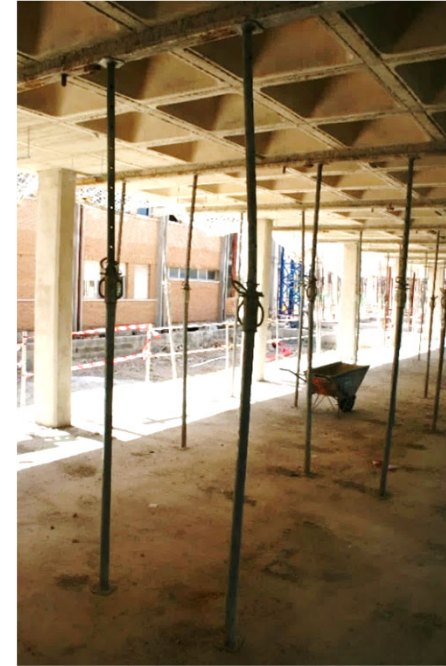
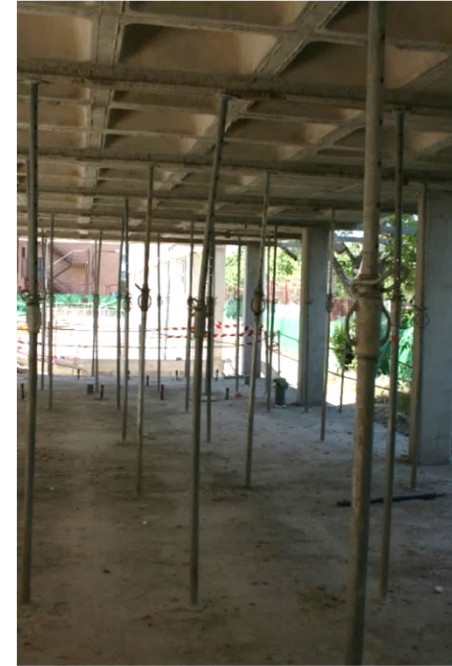
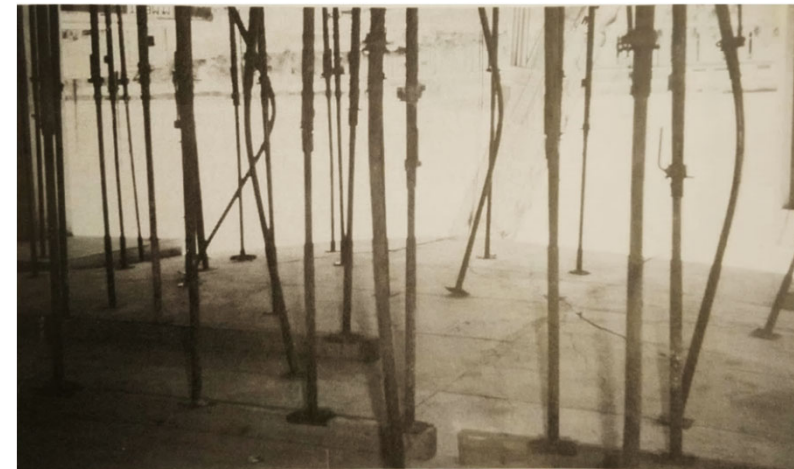
## Damage (slabs and shores)

C.L. Freyermuth, Structural integrity of buildings constructed with unbonded tendons, Concr. Int. 11 (1989) 56–63.

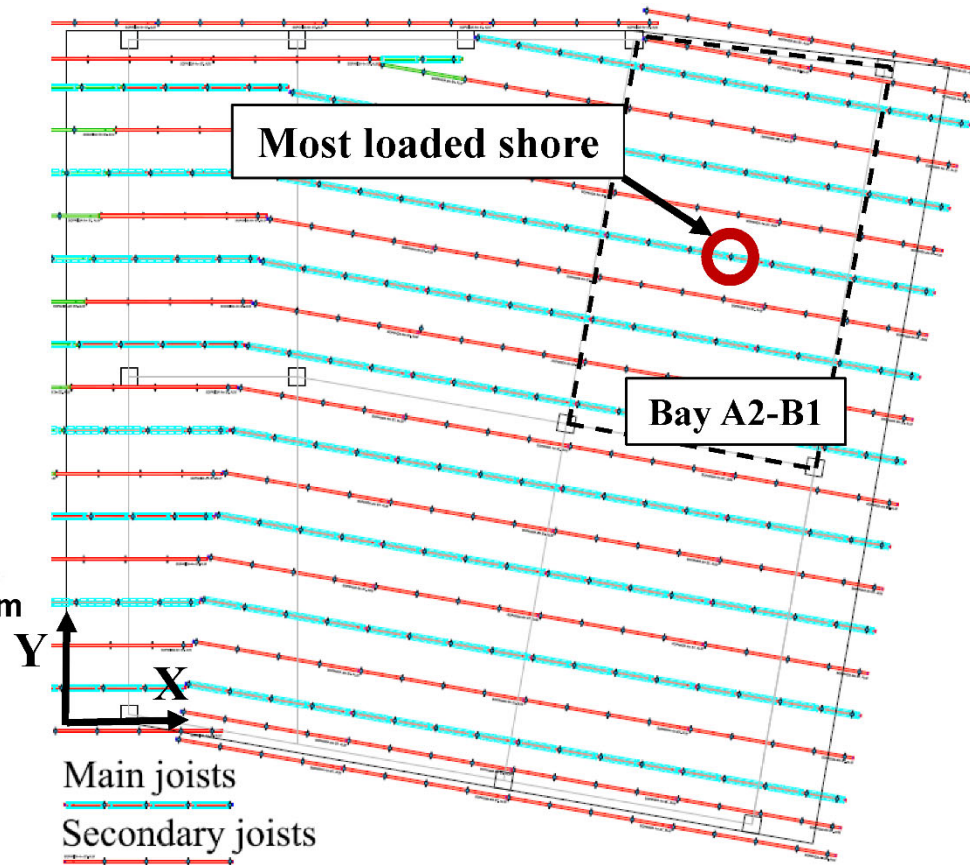
### Building and shoring system

First approach to the effects of sudden failure of shoring elements during the construction of RC building structures

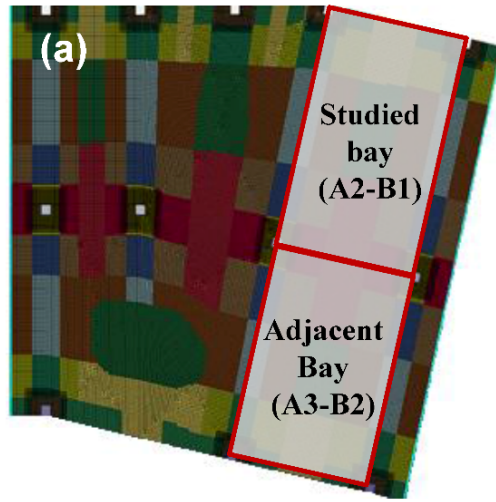
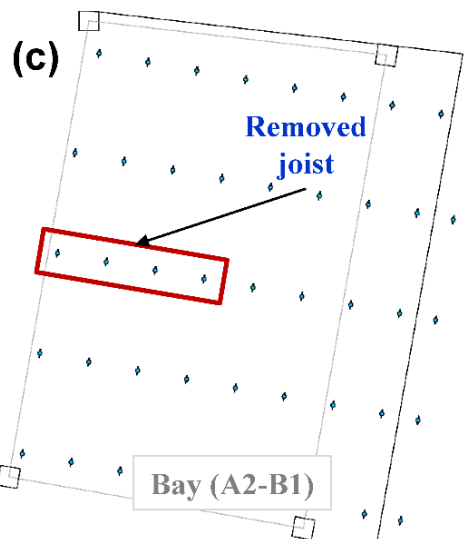
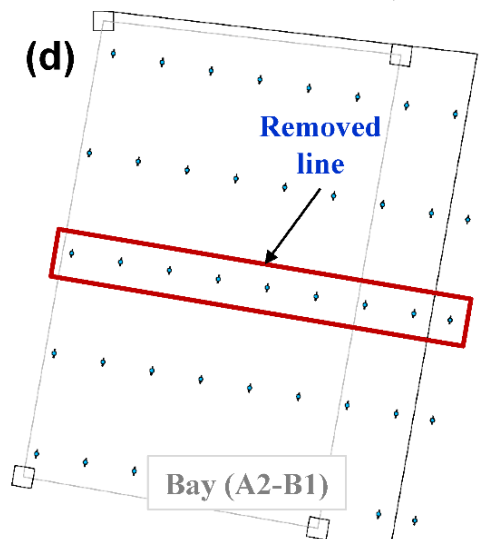
## FEM and failure scenarios

LS-DYNA©

Progressive collapse of the shoring system

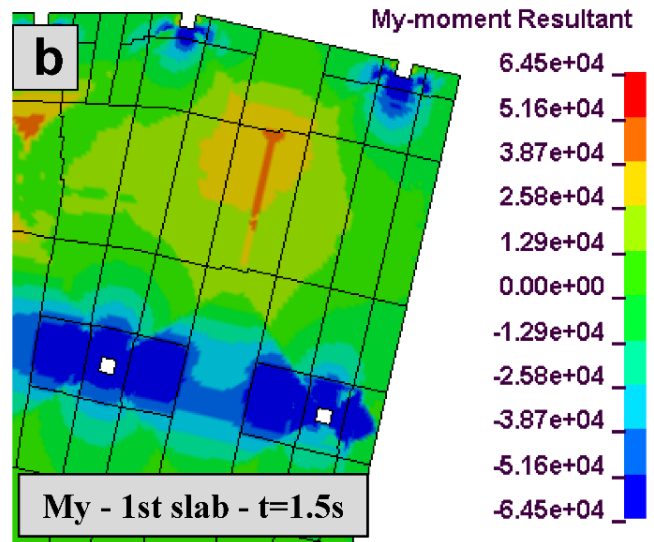
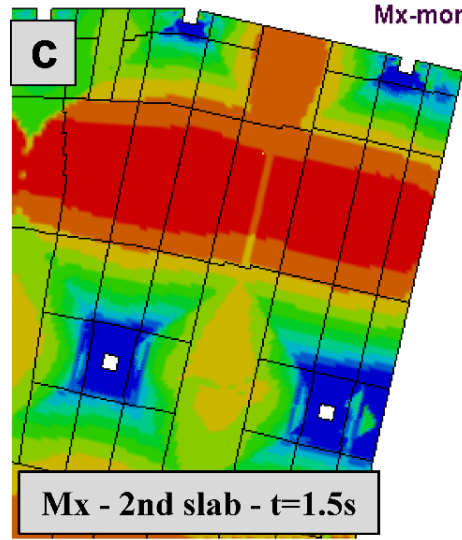
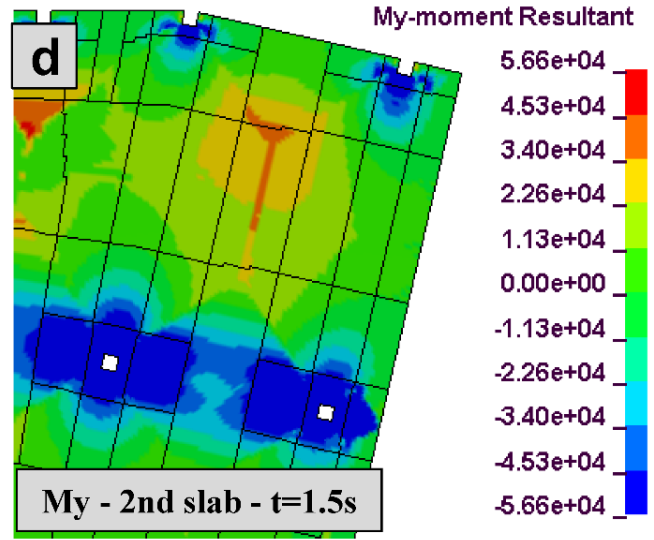
## 4<sup>th</sup> scenario (incorrect selection of shores)

No collapse of the RC structure

- Significant damage:
- Durability
  - Serviceability conditions
  - Short and Long-Term behaviour
