## VULNERABILITY PARAMETERIZATION FOR MASONRY CHIMNEYS BY MEANS OF A LIMIT ANALYSIS APPROACH

**Keywords:** Chimneys, Masonry construction, Seismic vulnerability, Limit Analysis LA

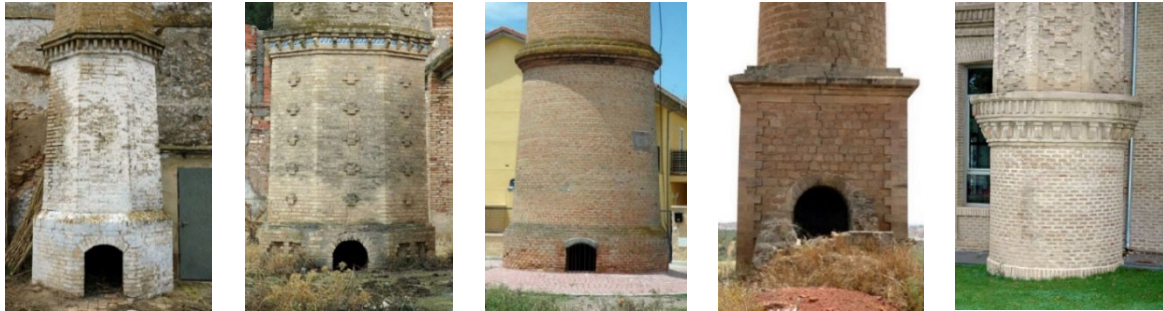
Figure 1: Different configurations of chimney's base taken from masonry chimneys in Spain, [14].

The Base: - The cross-section of the base is typically square, despite the cross-section of the shaft may be generally circular or octagonal. Commonly, it is built with bricks, but it can also be found completely built in ashlar. Sometimes the base was altered between bricks and ashlar

at the corners. These considerations could make us believe that a better material is expected in this zone. The typical dimensions of the base height vary from 3 to 5 m. Some illustrative examples of bases from Spanish masonry chimneys are depicted in Figure 1.

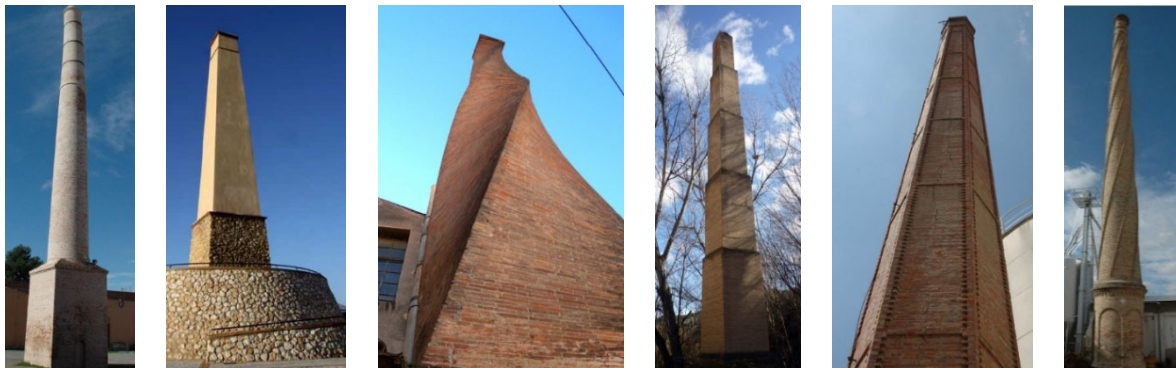
Figure 2: Different examples of chimney's shaft taken from masonry chimneys in Spain, [14].

**The Shaft:** - This is the most important and functional part of a chimney, making possible the expelling process of the produced industrial fumes. The cross-section of the shaft, which may differ from the cross-section of the base, characterizes the type of the chimney. Four typical shapes are used to build the cross-section of the shaft: square, circle, hexagon or octagon, see Figure 2. The shape of the shaft is related to aerodynamical effects, but mostly it demonstrates the construction tradition of a specific zone. The outer diameter of the shaft usually decreases, following the slope of the shaft that takes a value between 1% and 3%. The thickness of the shaft wall does not remain constant through height, but typically it reduces by one brick width (12cm) every 4÷6m height [14].

This study encompasses a wide range of geometrical parameters (represented in Figure 2) basing on comprehensive surveys carried out on Spanish masonry chimneys. In the following table, it is summarized the range of these parameters, which will be uniformly generated at random, in the absence of a full statistical database of their actual statistical distribution.

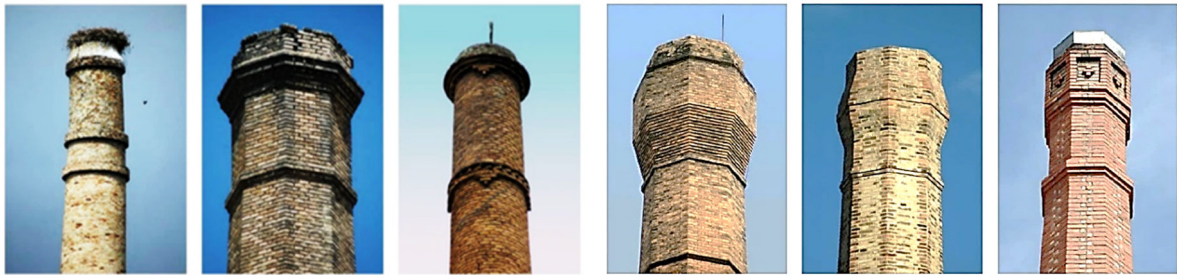
Figure 3: Different types of crowns taken from masonry chimneys in Spain, [14].

**The Crown:** - It is an extension of the stack with a main ornamental function aimed to attract the attention. These decorations, mostly in combination with the aerodynamical aspects lead to a slight enlargement of the section and weight of the crown. Some illustrative examples of crowns are depicted in Figure 3.

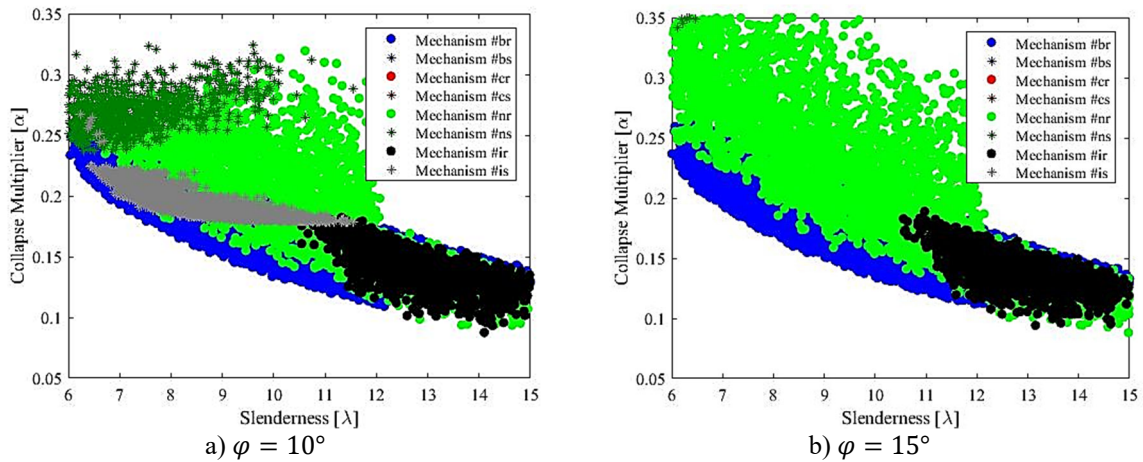
Figure 6: Collapse load multiplier variability by changing the friction angle of the masonry material.

The first investigation is performed varying the friction angle. Figure 6 reports the expected collapse load multiplier and the active failure mechanism for two values of the friction angle, respectively  $10^\circ$  and  $15^\circ$ . In the first case, some failure mechanisms related to shear sliding of the crown, neck, and shaft blocks are active, while in the second case, they are almost absent. Since a reasonable friction angle for masonry is around  $30^\circ$ , it may be concluded that a shear failure mechanism is not much probable to be active in chimneys.

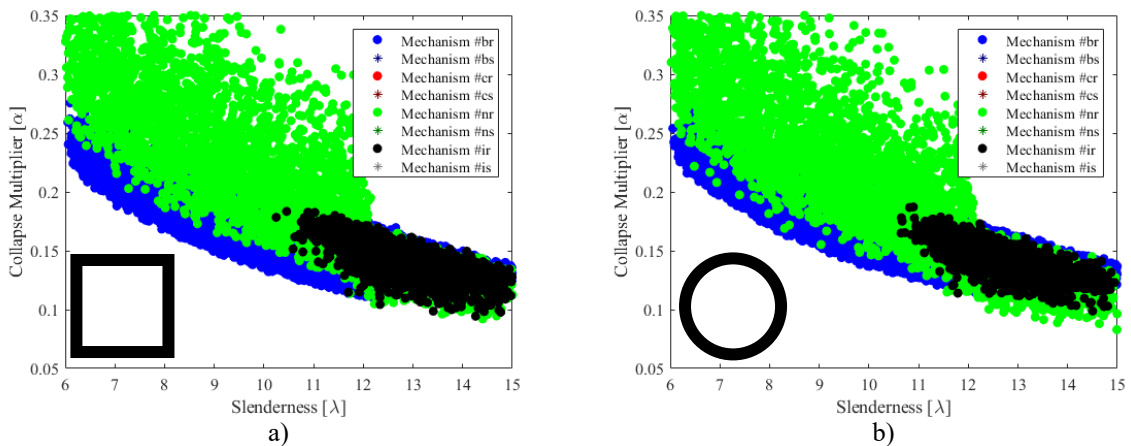
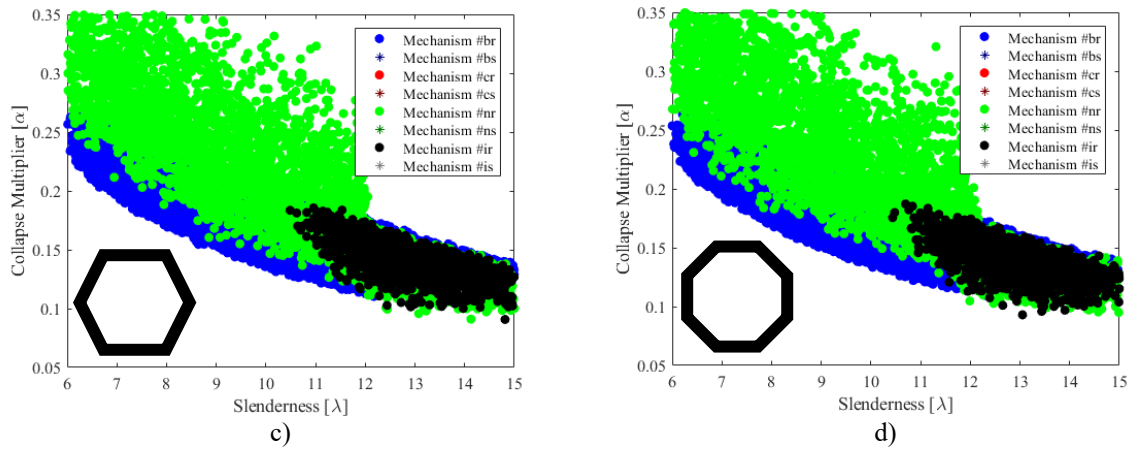
Figure 8: Collapse load multiplier variability by changing the cross-section of the chimney.

The last parameter investigated is the cross-section. As shown in Figure 4, four different cross sections are common for masonry chimneys, namely square, circular, hexagonal and octagonal. Hence the possibility of differing their performance is investigated. Figure 8 presents the collapse load multiplier for all the considered sections, and as can be noted, a not meaningful difference exists.

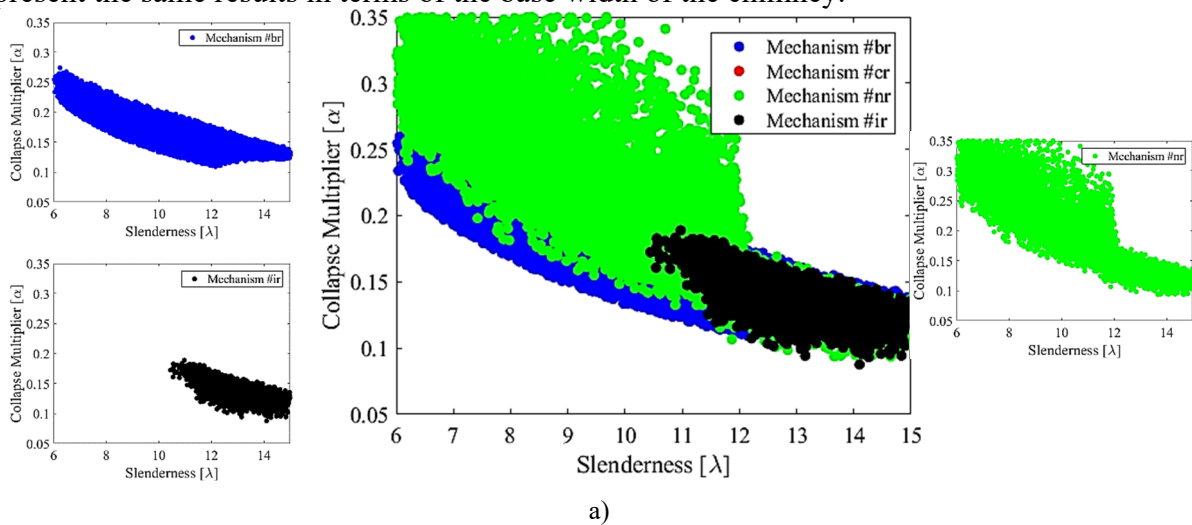
Figure 9: Collapse load multiplier variability respectively by changing the a) Slenderness; b) Height and c) Base width.

The above considerations lead to focus attention on failure mechanisms associated to rocking. Among the supposed mechanisms, the crown rocking has very low probability to occur because of the geometrical features, therefore no active mechanism is observed from the numerical simulations. The collapse load multiplier is depicted against slenderness, height and base width of the chimney. In order to distinguish the overlapping graphical effect, a single graph is plotted for each failure mechanism aside from each central image, Figure 9. From Figure 9-a) it can be noticed a change in the trend of the failure mechanism related to the base rocking and neck rocking. It occurs for slenderness roughly higher than 12, and it is followed by a new failure mechanism activated in the shaft blocks. From Figure 9-b), failure of the neck has two distinct branches. The first branch is isolated by a limited height of 15 m which corresponds to the simplest configuration of the chimney, crown-neck-base. The expected collapse multiplier for this branch is very diffused, while for the second branch follows a linear trend. The same trend is also observed for the other mechanisms, i.e., shaft rocking and base rocking. Figure 9-c) present the same results in terms of the base width of the chimney.

The above illustrations are an endeavor to estimate the vulnerability of the masonry chimneys in terms of active failure mechanism and the lowest collapse load multiplier. The numerical results highlight a very high vulnerability of these structures, especially related to the local failures at the upper parts of the structure. From different supposed failure mechanism, four for each rocking motions and sliding one, only three of them are more probable to occur.
