Influence of infill masonry walls in RC building structures under corner-column failure scenarios

Buitrago, Manuel¹; Bertolesi, Elisa²; Calderón, Pedro A.³; Moragues, Juan J.⁴; Adam, Jose M.⁵

ABSTRACT

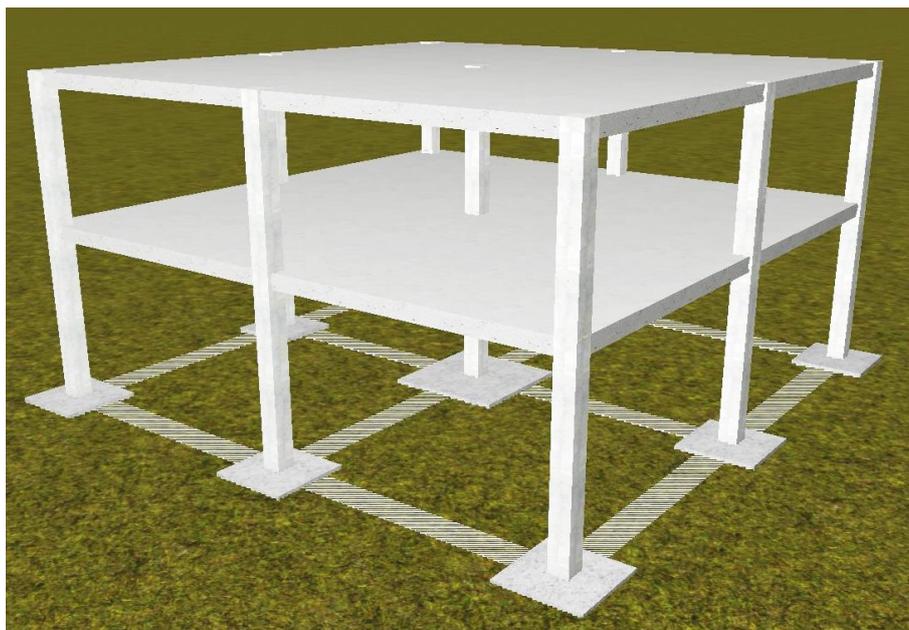
Figure 1. 3D view of the design.

A real-scale RC building was designed with only research purposes. This building had two floors of 2.8m height, four bays with 5.0m span length, flat-slabs 20cm thick and columns of 30x30cm². Prescriptions of Eurocode 2 [12] were adopted and a category of use corresponding to high occupancy buildings (C1, C2 o C3) [13] was chosen. In addition to the self-weight of the structure, a dead load of 2kN/m² and a uniformly distributed live load of 3kN/m² were considered in the design of the structure.

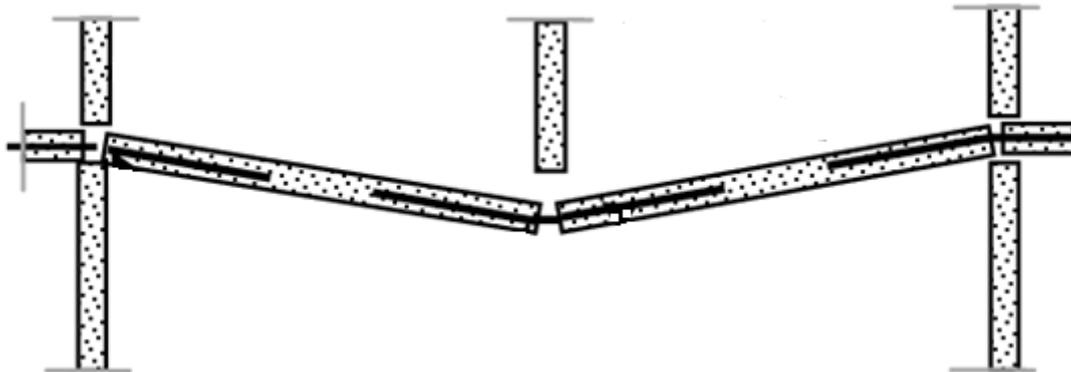
Figure 2. Example of horizontal ties working after an internal-column loss.

The building, under accidental actions, was verified following EC-1, part 1-7 [2], for a consequence class 2b (Upper Risk Group). At this point, the building was designed using the simplified methodology of the tying forces and elements (horizontal and vertical ties). A discussion about the origins and the validity of the tying simplified methodology is discussed in [6]. As a result, the design of the building was only slightly modified with respect to the design without accidental actions. This is a common trend when considering flat-slabs, as pointed out in [6]. Fig. 2 shows an example of horizontal ties working after an internal-column loss.

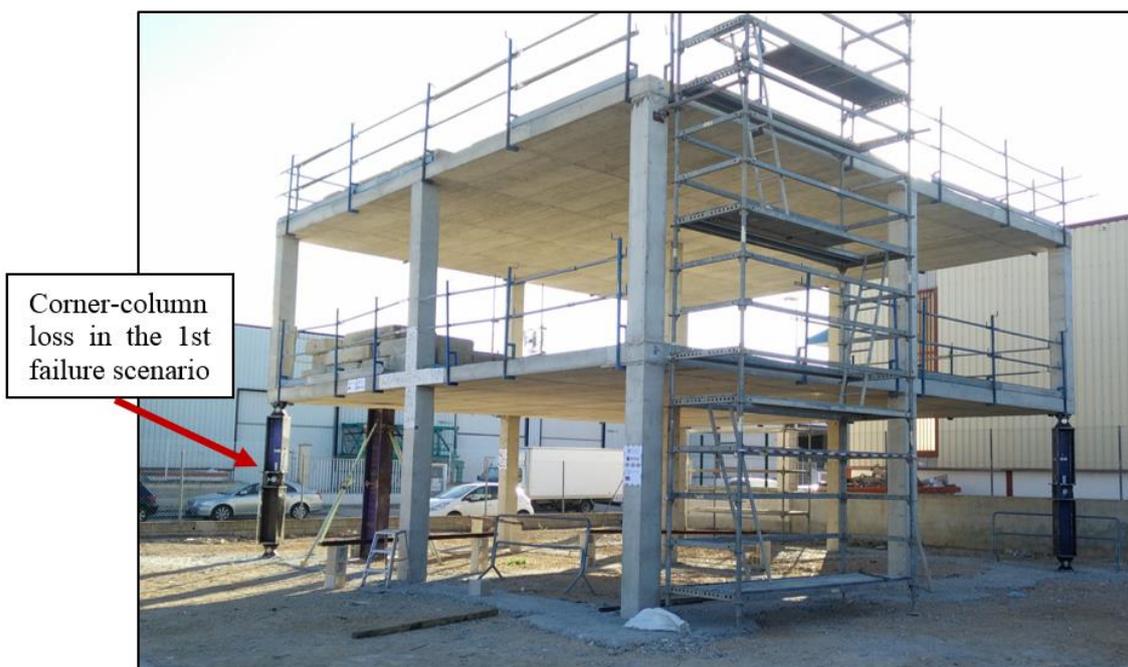
Figure 3. Building and definition of the first failure scenario.

Two experimental tests for two different failure scenarios were considered in this study. In both cases, a corner-column loss was considered, selecting two opposite corners columns to avoid the influence of a damaged structure in the second test. These columns were steel-based (HE-300B profile) prepared with a mechanism to reproduce a sudden failure. Only the structure of the building was tested for the first failure scenario, whereas infill masonry walls were also introduced for the second failure scenario. These masonry walls were only reproduced in the first floor and in those modules with more influence in the defined corner-column failure scenario. Fig. 3 and Fig. 4 show the real building prepared for the first and the second failure scenarios, respectively.

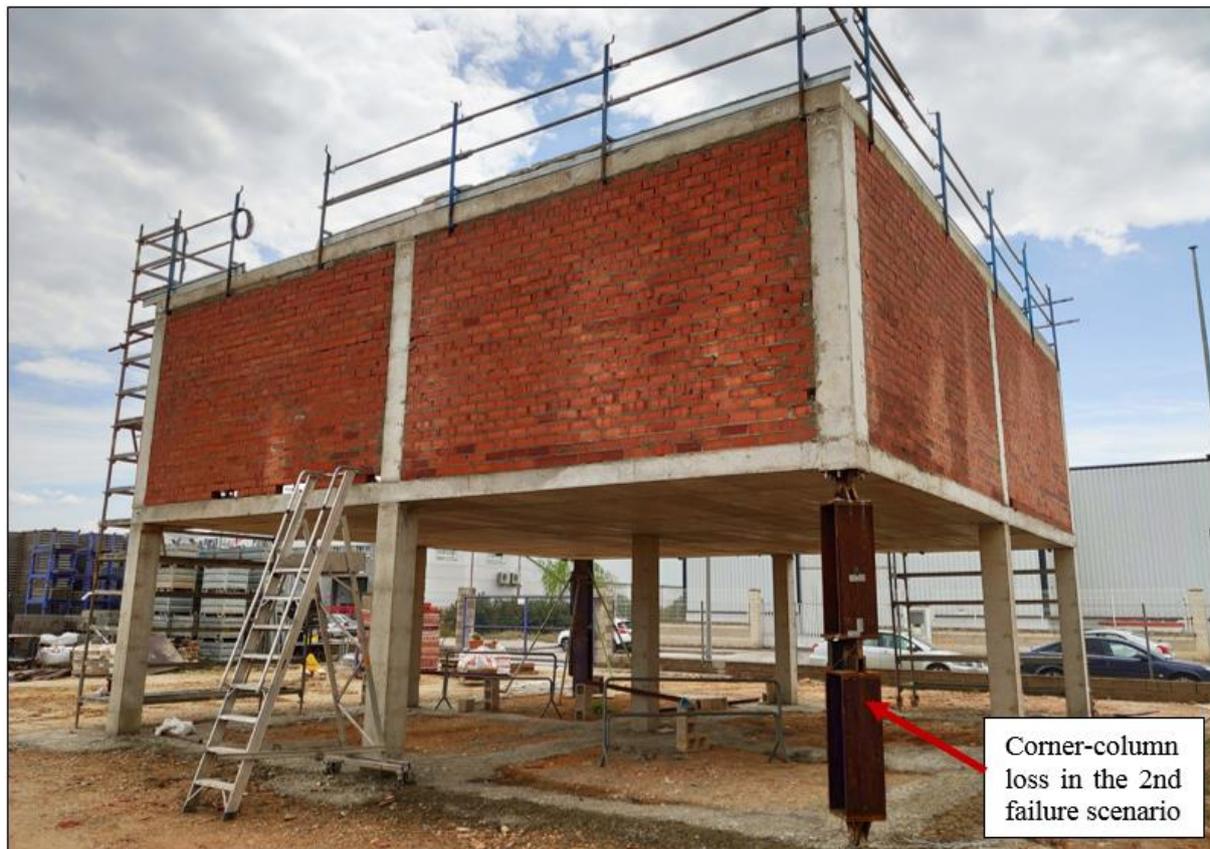
Figure 4. Building and definition of the second failure scenario.

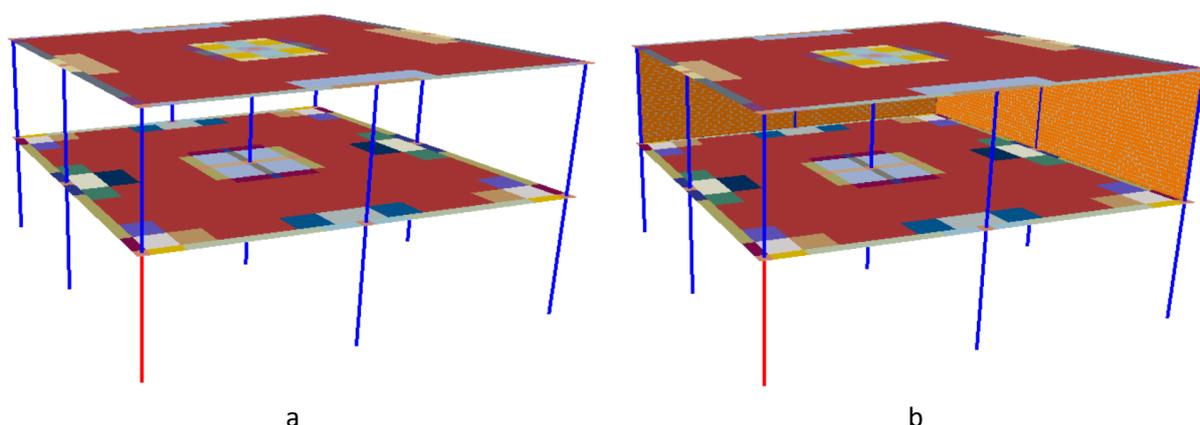
Figure 5. 3D view of the FE model without (a) and with infill masonry walls (b).

RC and steel columns were modelled as BEAM elements (B33) with an elastic behaviour, considering that cracking in the concrete columns should be reduced. SHELL elements (S4R) were used for flat slabs and the infill masonry walls. For the floors, different areas with different amount of reinforcement were considered according to the structure design. A concrete damage plasticity model was adopted to reproduce the non-linear behaviour and damage of the concrete, adopting those expressions given by EC-2 [12]. As a first approach, results for the model with infill masonry walls were not predicted due to the variability of the results according to the unknown mechanical properties and connections with the RC structure. This model will be performed as a future work based on the

The lower nodes of the concrete columns of the ground floor had restricted displacements and rotations, whereas those corresponding to the steel columns had restricted displacements and free rotations. Fig. 5 shows a 3D view of the FE model.

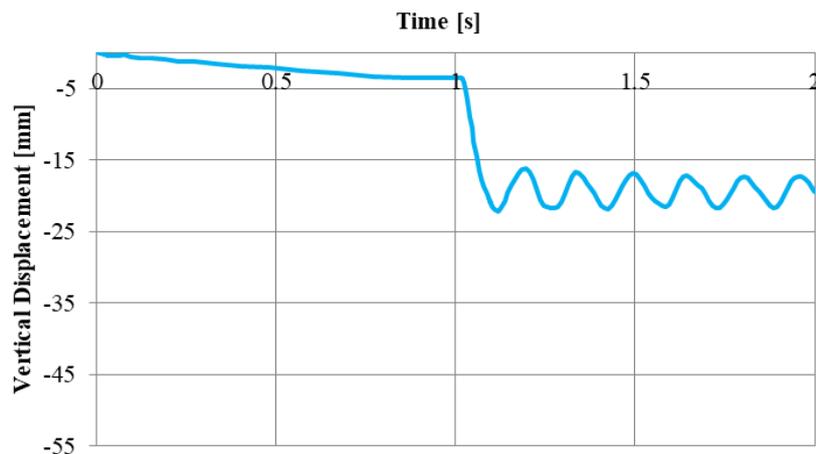
Figure 6. Position and time-dependent results (vertical displacement) in the center of the bay attached to the failed column.

Fig. 6 and Fig. 7 show the time-dependent vertical displacement obtained in the centre of the bay attached to failed column and in the upper point of this column for the first failure scenario, respectively. As it is shown, the RC structure achieve an important deflection after the accidental event within $t = 1.0s$ and $t = 2.0s$. This response, as can be seen from the deformed shape, is governed by two main alternative load paths: a) bending; and b) Vierendeel action. Other alternative load paths, as membrane or arch action, were not mobilized in this case. Arch action can be mobilized when an external or internal column is lost, whereas membrane action is usually activated after the bending action, with high rotations at joints and a stiff horizontal restrain.

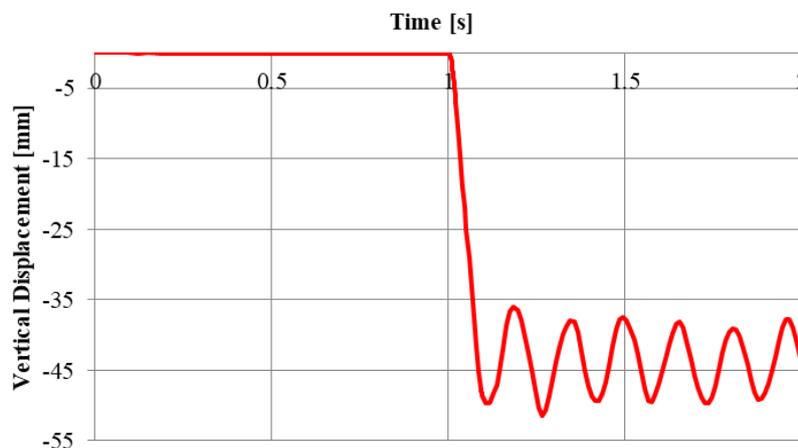
Figure 7. Position and time-dependent results (vertical displacement) in the upper point of the failed column.

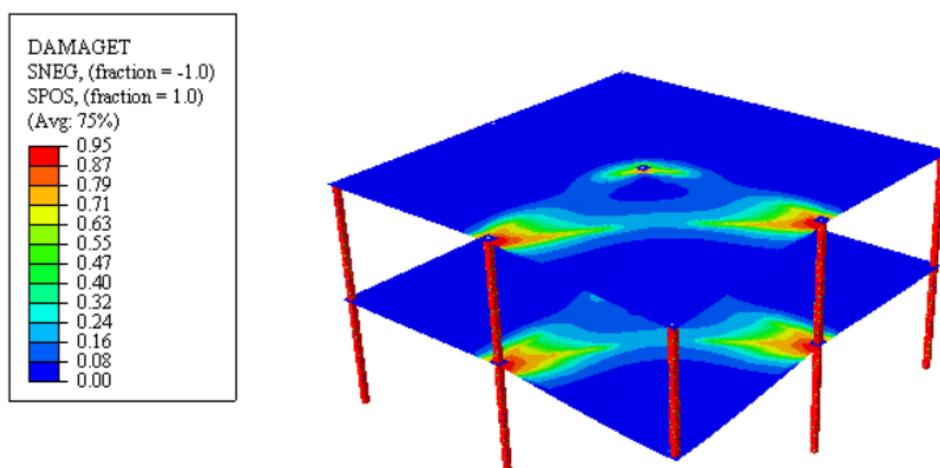
Figure 8. Predicted tensile damage of the upper part of RC slabs in the first failure scenario (deformed shape magnified 10 times) at 2 s.

Fig. 8 and Fig. 9 show the predicted damage (cracking) on the upper and lower part of the RC slabs, respectively. The most important cracked areas are represented as grey areas. As can be seen, this damage is localized in zones near the joints between slabs and columns, where negative bending moments are important after the accidental event. Damage is also localized in the bottom part of the slabs near the failed column due to the flexural stresses introduced by the Vierendeel action. As an example of what occurred in the experimental test, Fig. 10 shows a photography of some cracks produced on the slabs near to the column-slab joint attached to the failed column after the accidental event.

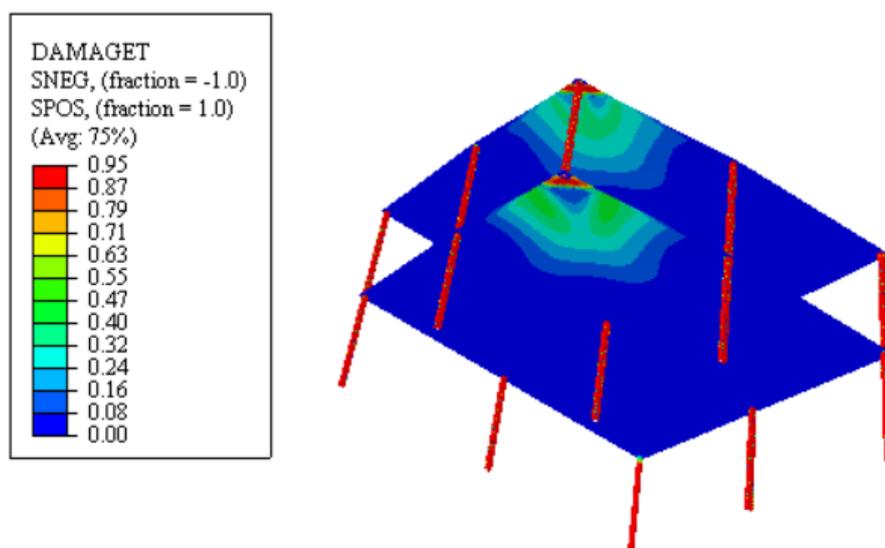
Figure 9. Predicted tensile damage of the lower part of RC slabs in the first failure scenario (deformed shape magnified 10 times) at 2 s.

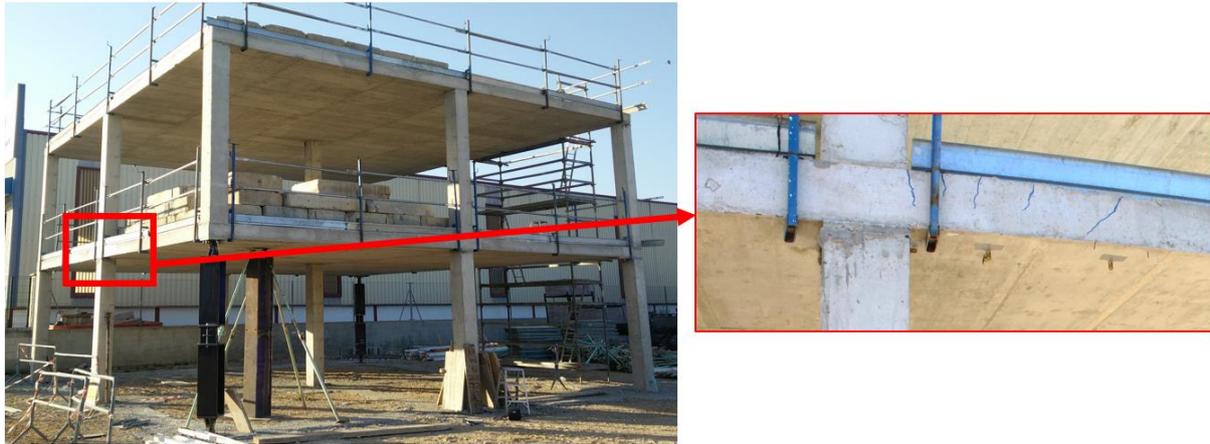
Figure 10. Cracks on the slabs near the joint column-slab attached to the failed column after the accidental event in the experimental test.
